Testing and Evaluation of the

W-Beam Transition (On Steel Posts

With Timber Blockouts) to the

Vertical Flared Back Concrete

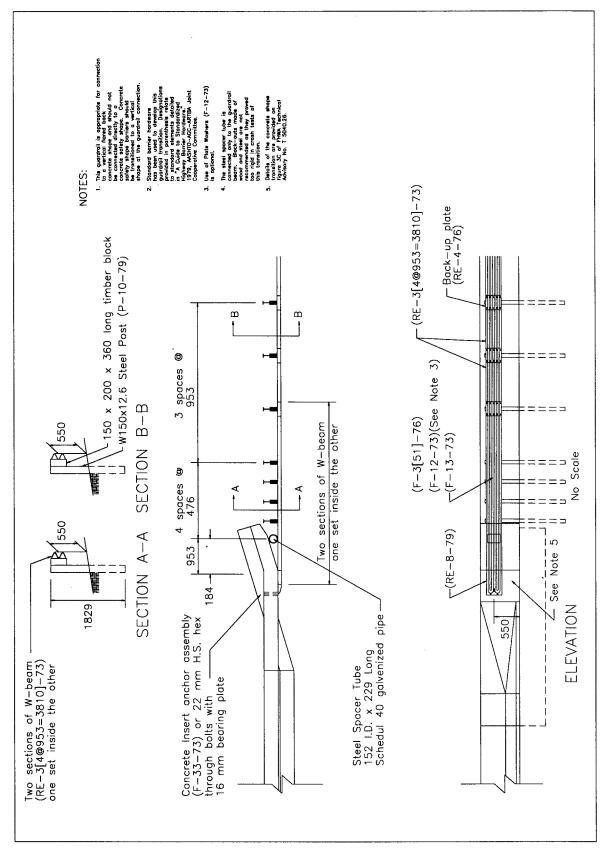
Figure 1. Details of the W-beam transition (on steel posts with timber blockouts).

The W-beam transition was modified by using 150-mm by 200-mm by 360-mm timber blockouts on W150×12.6 steel posts. A full-scale crash test with the 2000-kg pickup truck traveling at a nominal speed and angle of 100 km/h and 25 degrees, respectively, was performed on the modified G4(IS) guardrail with timber blockouts. The modified system contained and redirected the 2000-kg pickup. However, the pickup rolled over after exiting the test installation.

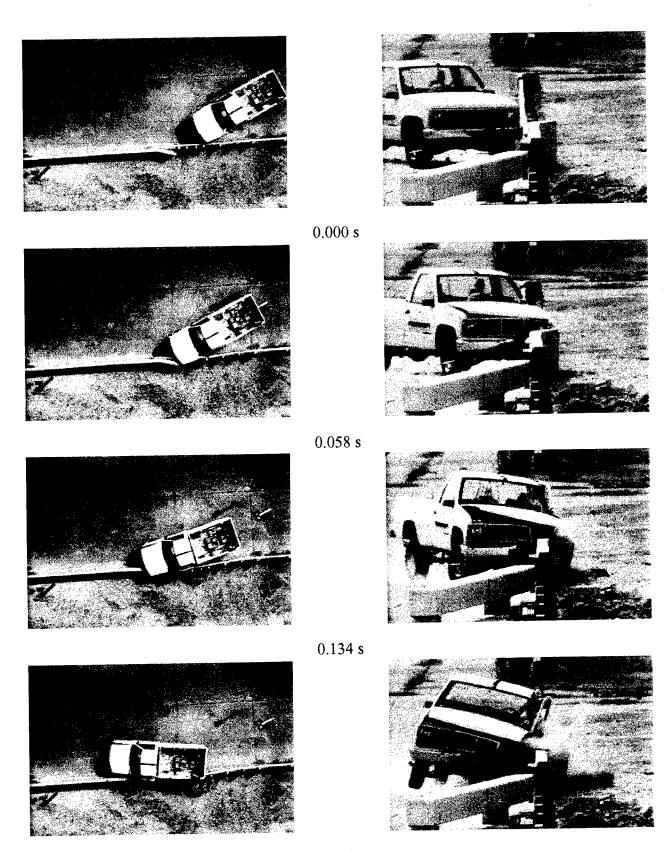
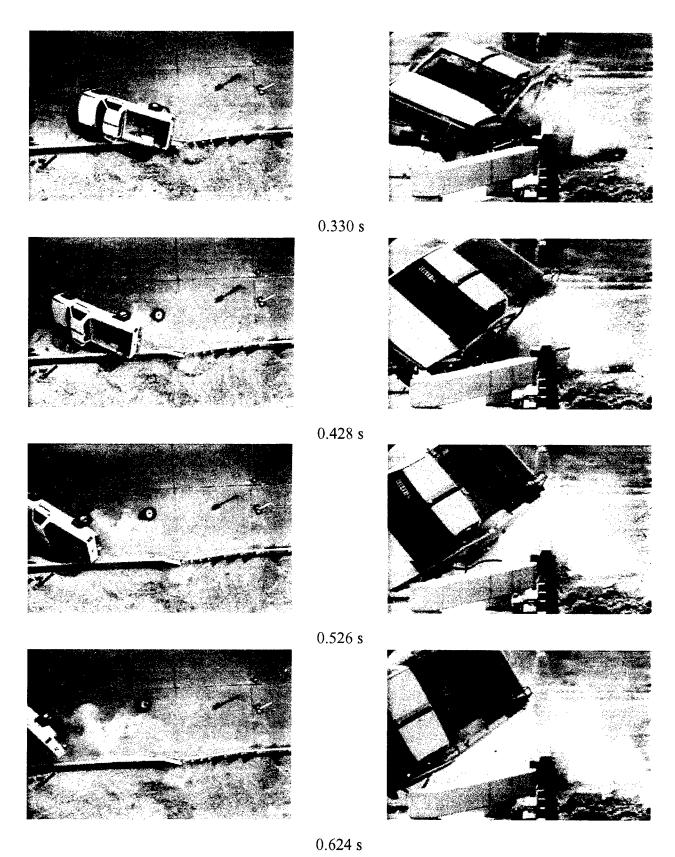
Figure 8. Sequential photographs for test 405491-2 (overhead and frontal views).

The test vehicle, traveling at a speed and angle of 99.8 km/h and 25.3 degrees, impacted the transition section 150 mm upstream of post 4, which was determined to be the Critical Impact Point (CIP). Shortly after impact, movement was noted at posts 4, 3, and 2, respectively. At 0.022 s, the front of the vehicle made contact with post 3 and, at 0.024 s, post 1 began to move. The front of the vehicle made contact with post 2 at 0.039 s and with post 1 at 0.053 s. At 0.066 s, the front of the vehicle impacted the end of the flared back concrete bridge parapet. The vehicle began to redirect at 0.068 s and the bridge parapet began to move at 0.077 s. At 0.194 s, the vehicle became parallel with the transition, traveling at a speed of 72.4 km/h. The rear of the vehicle impacted the W-beam rail element at 0.245 s and the concrete parapet at 0.272 s. At 0.289 s, the rear bumper caught on the bridge parapet. The vehicle lost contact with the bridge parapet at 0.573 s, traveling at an exit speed and angle of 66.2 km/h and 18.5 degrees. As the vehicle exited the test installation, it yawed clockwise and rolled counterclockwise. The vehicle rolled 360 degrees and subsequently came to rest facing the impact point 47.5 m down and 11.9 m forward. Sequential photographs of the test period are shown in figures 8 and 9.

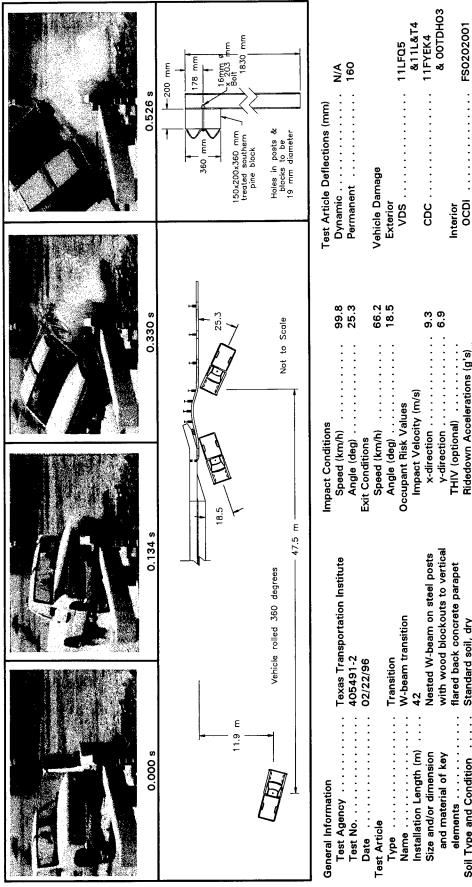
Figure 15. Summary of results for test 405491-2.

The W-beam transition (on steel posts with timber blockouts) to the vertical flared back concrete bridge parapet contained and redirected the vehicle through controlled lateral deflection. The vehicle did not penetrate or go over nor under the transition. However, there was some snagging of the vehicle as it impacted the end of the concrete parapet wall. There were no detached elements or debris to show potential for penetrating the occupant compartment or to present undue hazard to others in the area. Occupant deformations from the initial impact were moderate and may not have caused serious injury. However, deformations which occurred from the rollover after the vehicle exited the installation may have caused serious injury. The vehicle remained upright during the collision and then rolled 360 degrees upon exiting the test installation. The vehicle yawed and then rolled into the adjacent traffic lanes. The occupant risk factors were within the limits specified in NCHRP 350. The exit angle at loss of contact was 18.5 degrees, which was greater than 60 percent of the test impact angle.
